# Manhole Inspection Summary

Manhole # S07QQ1013MH

Insp Date: **12/23/08 11:21 AM**

**Location** Address: **3215 W. BELVEDERE AVE**

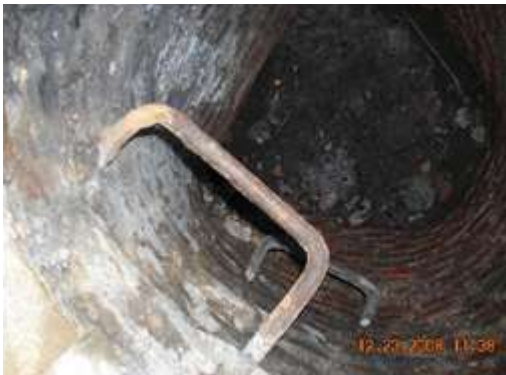
Defect 2

Count: **3** Missing: **0** ☒ **Corroded**

CORRODED STEPS

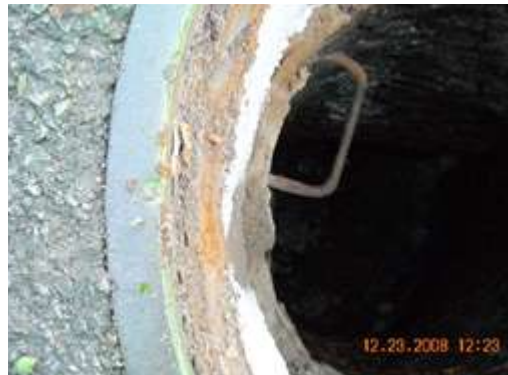
Defect 5

Offset: **1.** (in.)  
**15**

MH FRAME OFFSET OF 1.5"

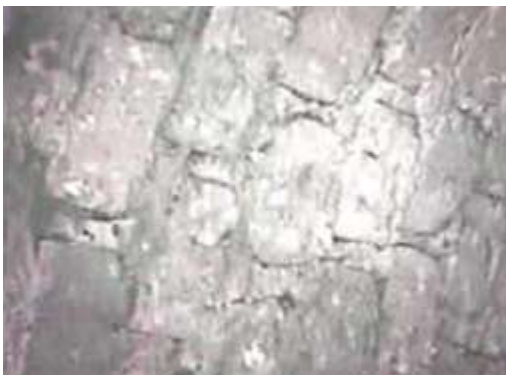
Defect 4

Condition: ☐ Sound ☒ **Cracked** ☐ Root Intrusion ☐ Loose Brick ☒ **Deteriorated**

DETERIORATING BRICKS AND  
CRACKS IN CORBEL WALL

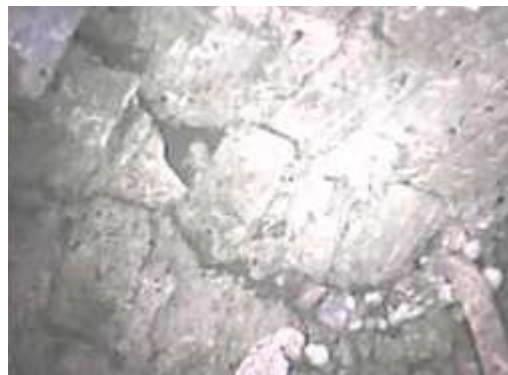
Defect 3

EVIDENCE OF INFLOW AND  
DETERIORATION OF CORBEL WALL

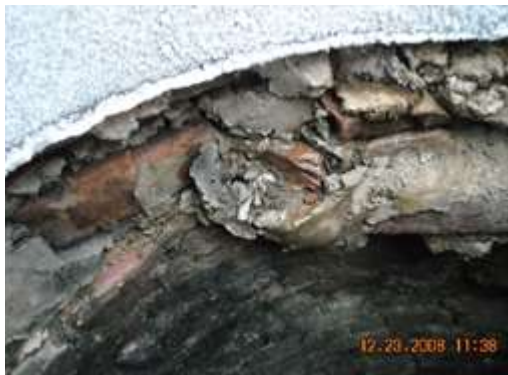
### Defect 1

Condition: ☐ Sound ☒ **Cracked** ☐ Root Intrusion ☒ **Loose Brick** ☒ **Deteriorated**

CHIMNEY ADJUSTMENT IS  
DETERIORATED AND MISSING  
BRICKS AND CRACKS
